## Fracture of a Ceramic Femoral Head after a Revision Operation

A CASE REPORT\*

BY IAN T. PULLIAM, D.O.†, AND ROBERT T. TROUSDALE, M.D.†, ROCHESTER, MINNESOTA

*Investigation performed at the Department of Orthopedics, Mayo Clinic and Mayo Foundation, Rochester*

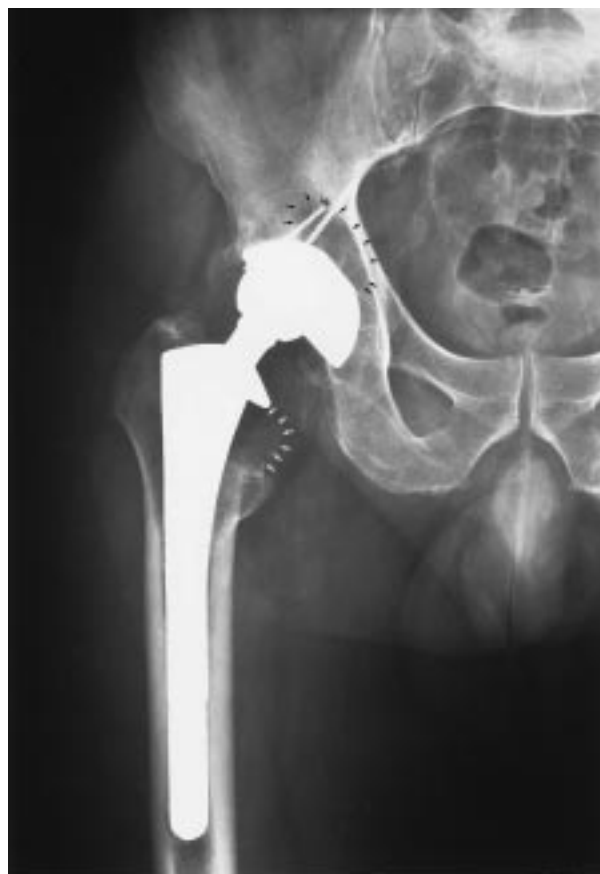
FIG. 1

substantial osteolysis of the acetabulum and the proximal medial portion of the femoral neck (Fig. 1). An arthrogram showed no evidence of loosening, and cultures of material aspirated from the hip were negative.

The patient had a revision arthroplasty in September 1993. The intraoperative findings included diffuse metallosis, a fractured polyethylene component, and a scored femoral head and acetabular shell. Because of the large cavitory defect in the acetabulum, morselized allograft and a reinforcement ring (Ganz; Protek AG, Berne, Switzerland) were utilized for revision of the acetabular component. A fifty-eight-millimeter all-polyethylene cup was inserted, with cement, into the reinforcement ring. The femoral component was found to be

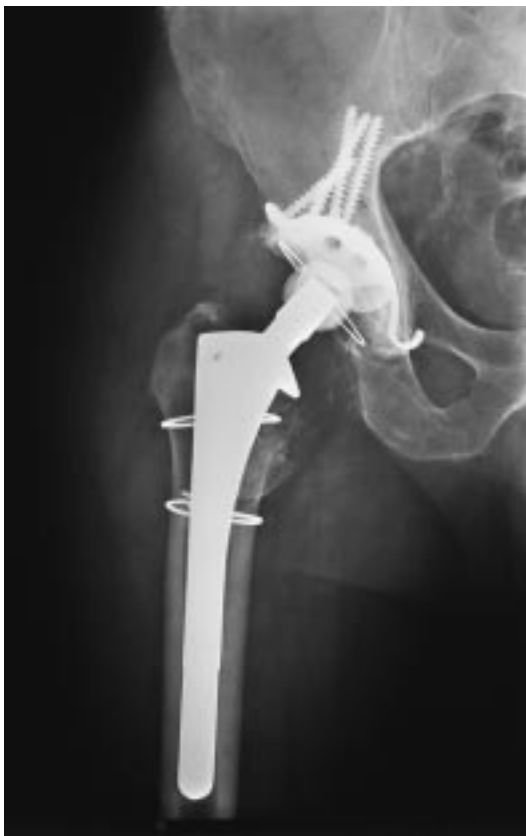
FIG. 2

Postoperative anteroposterior radiograph demonstrating the reinforcement ring, the ceramic femoral head, and the 2.0-millimeter cables that were used to secure the allograft bone struts that had been inserted into the deficiencies in the proximal part of the femur.

solidly fixed. The femoral head was removed, and the trunnion of the intact femoral prosthesis was found to have minimum scoring and no obvious imperfections. Because of the history of extensive polyethylene wear, a twenty-eight-millimeter zirconia ceramic femoral head with a +3-millimeter offset (DePuy) was placed on the taper of the anatomic medullary locking stem (Fig. 2). The head was placed manually with a twisting motion and was gently impacted twice with a femoral head inserter. The postoperative course was uncomplicated, and the patient was able to return to full activity without any discomfort in the hip.

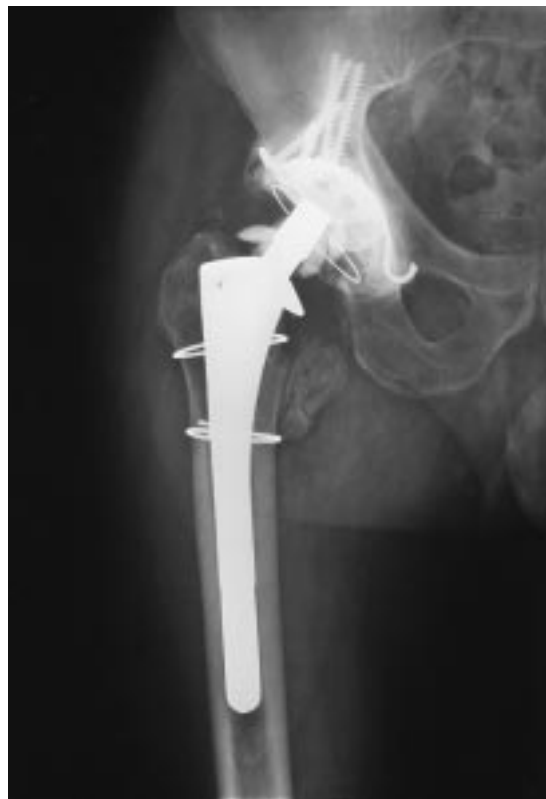
FIG. 3

Approximately one year after the revision, the patient heard a pop in the hip, which was followed by the onset of a mild ache. There was no history of trauma to the hip. Radiographs showed the ceramic femoral head to be fractured into multiple fragments (Fig. 3). Metallosis was found along the taper inside the ceramic femoral head as well as diffusely about the pseudocapsule. The acetabular grafts were well healed, and the acetabular and femoral components were well fixed. The ceramic fragments were removed, the area was well irrigated, and a twenty-eight-millimeter cobalt-chromium femoral head with a +5-millimeter offset was placed on the existing femoral stem (Fig. 4). The taper of the femoral component again was inspected, and no obvious imperfections were found. The postoperative course was uncomplicated. At the ten-week follow-up examination, the patient had no pain, used no walking aids, and had resumed normal activity.

Anteroposterior radiograph, made approximately one year after the revision total hip arthroplasty, showing the fracture of the ceramic femoral head.

Our patient was relatively heavy, which may have been a contributing factor. At the time of the revision, the femoral component was found to be well fixed. We chose to place a ceramic head onto the well fixed stem in light of the history of extensive polyethylene wear. Precise matching of the taper inside the femoral head and the taper of the trunnion of the femoral stem may be important in order to avoid areas of stress concentration. We believe that an unrecognized defect on the existing taper may have contributed to the fracture of the ceramic head. When a ceramic femoral head is used, careful insertion onto a taper with no imperfections may be important to the long-term performance of the ceramic.

We believe that a ceramic head may be a good choice for primary total hip arthroplasty, especially for a young patient. However, the use of a ceramic femoral head on an existing taper at the time of a revision arthroplasty probably should be avoided as minor, unrecognizable flaws on the taper may lead to the formation of cracks in the ceramic with subsequent fracture.

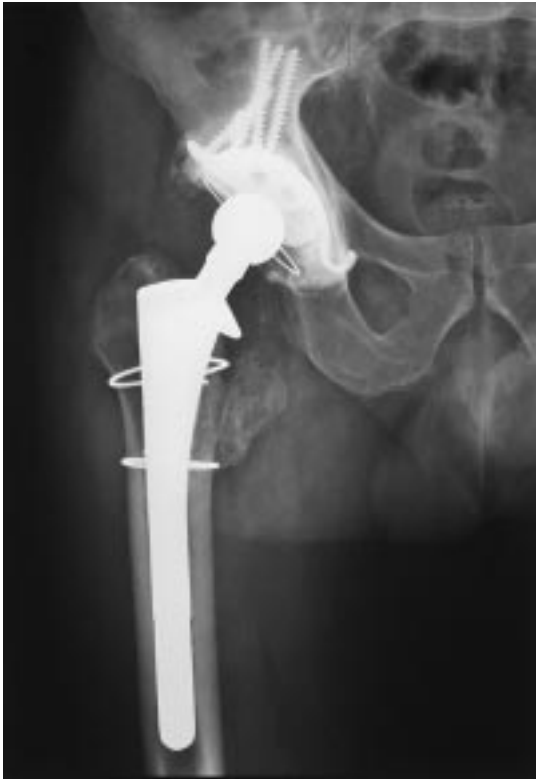
FIG. 4

Anteroposterior radiograph, made after repeat revision with use of a twenty-eight-millimeter cobalt-chromium femoral head.
